Fractography of Advanced Structural Ceramics: Results From The VAMAS Round Robin Exercise

Jeffrey J. Swab and George Quinn

ARL-TR-656

December 1994

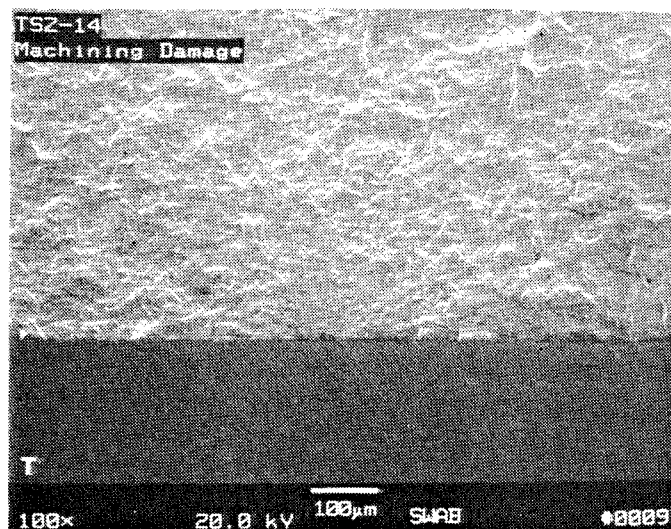
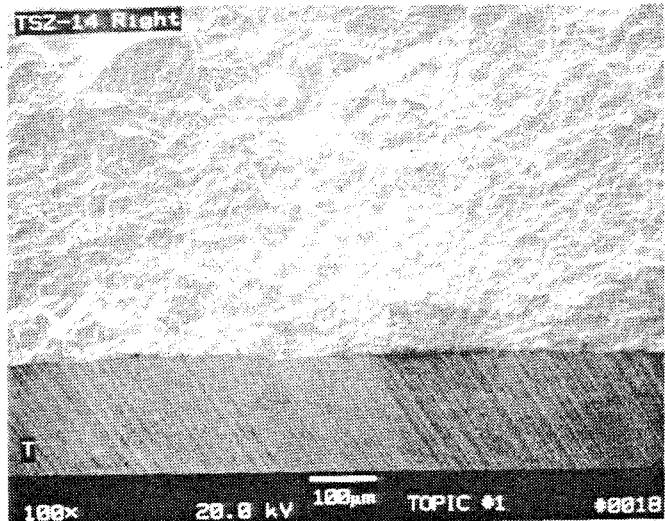
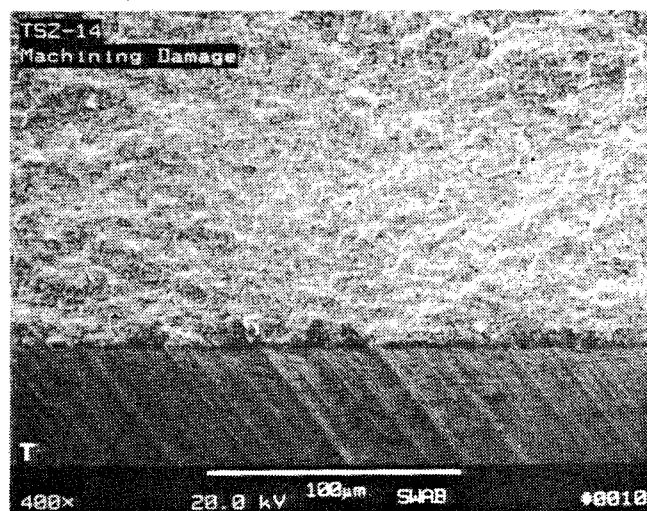
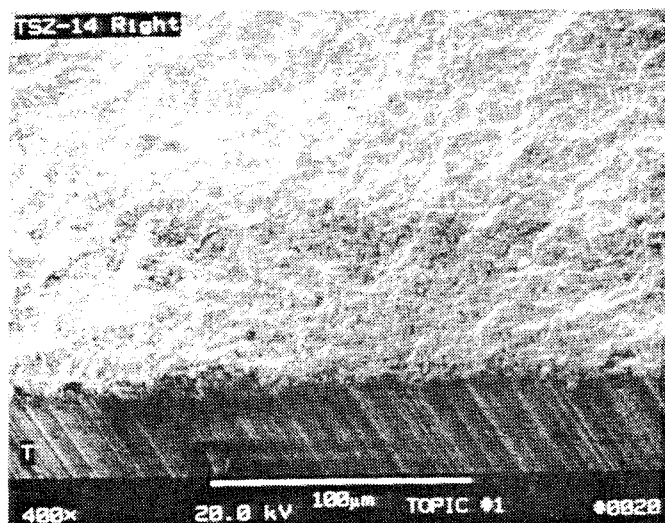
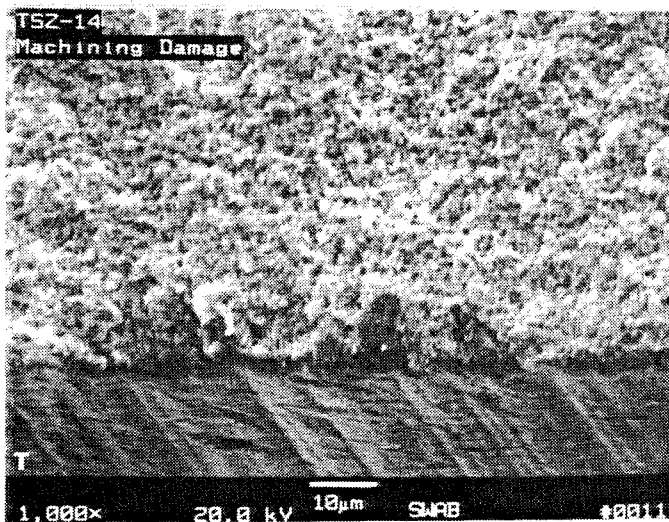
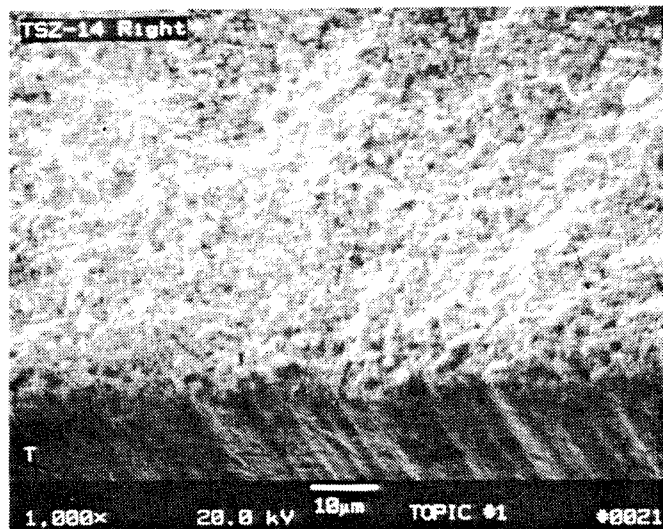
Figure 1.2. The three pairs of photographs for Set #1 (TSZ-14) which were provided to the participants. "T" denotes the tensile surface.

PARTICIPANTS' RESULTS - LOCATION IN ZIRCONIA/ALUMINA - The consensus was that the origin was located at the surface. However, one participant believed the origin was close to but not at the surface (thus the near surface label) while another established the origin as being located at an edge.

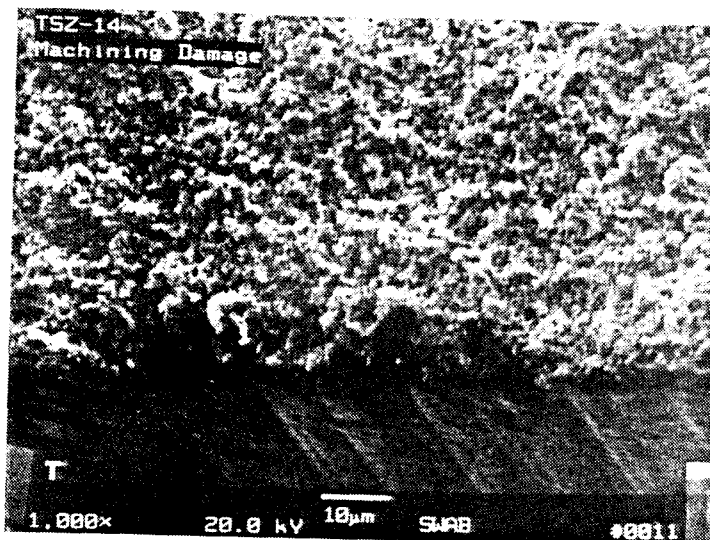
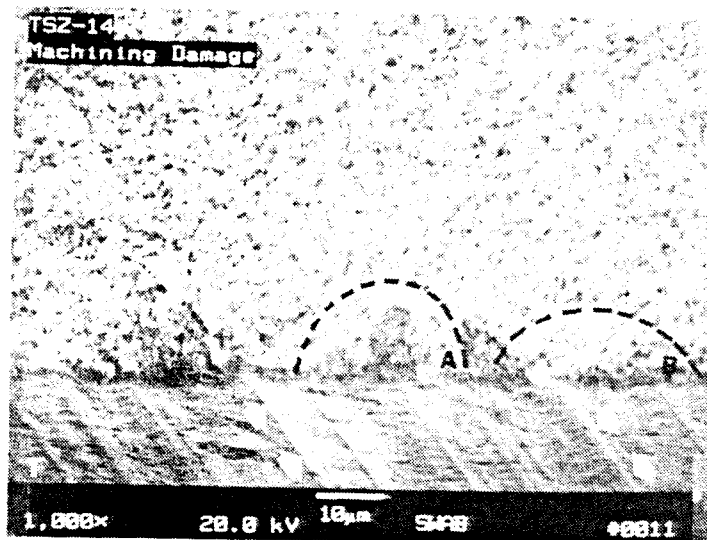
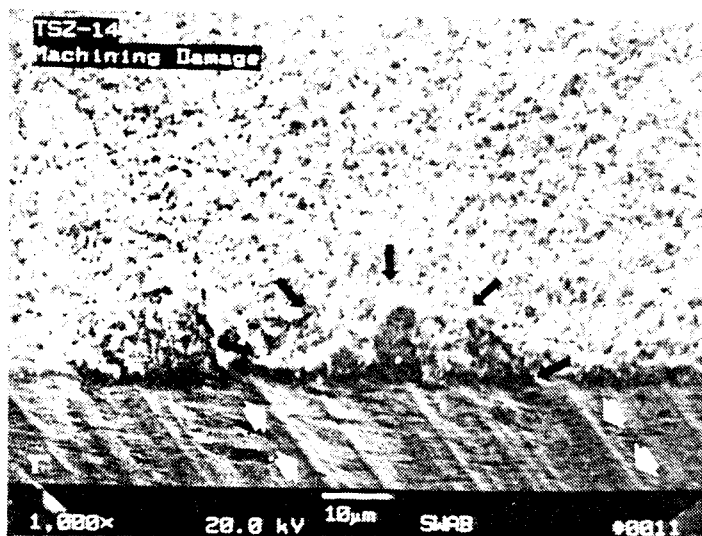
Figure 1.3. High magnification photographs of one half of the fracture surface from Set #1 (TSZ-14). A) Unmarked. B) The organizers outlined two possible semicircular origins. Arrows indicate possible striations on tensile surface. C) The organizers outlined a possible semielliptical origin. "T" denotes the tensile surface.

The origins outlined for set #1 (Zirconia/Alumina), Figure 1.3, and set #2 (Silicon Nitride), Figure 1.5, have essentially a semicircular or a semielliptical shape. The origin in set #3 (Alumina), Figure 1.7, is part of a circle. In Figure 1.3 (set #1) the origin outlined by the organizers can be closely approximated by a semicircle of radius, $c \approx 15 \mu\text{m}$. This is approximately three times larger than the value predicted by fracture mechanics ($K_{Ic} = 5$, $Y = 1.4$, and $\sigma = 1552$). This calculation assumes the material has a constant toughness. Zirconia-based materials have been shown to exhibit pronounced R-curve behavior for "long-cracks"²²⁻²⁴ and recent studies indicate that this phenomenon can be present with small cracks, i.e., at the scale of naturally occurring fracture origins, over relatively short crack extensions²⁵⁻²⁷. This "micro" R-curve behavior has shown that the fracture toughness can be as low as 1 to 3 $\text{MPa}\cdot\sqrt{\text{m}}$ for short cracks in a Y-TZP but increases to over 5 once the crack extends more than $10 \mu\text{m}$ ²⁷. This effect cannot account for the discrepancy in the present instance, since lower toughness values will lead to smaller crack sizes at criticality. Different toughness testing techniques can also yield different toughness values for the same material²⁸.

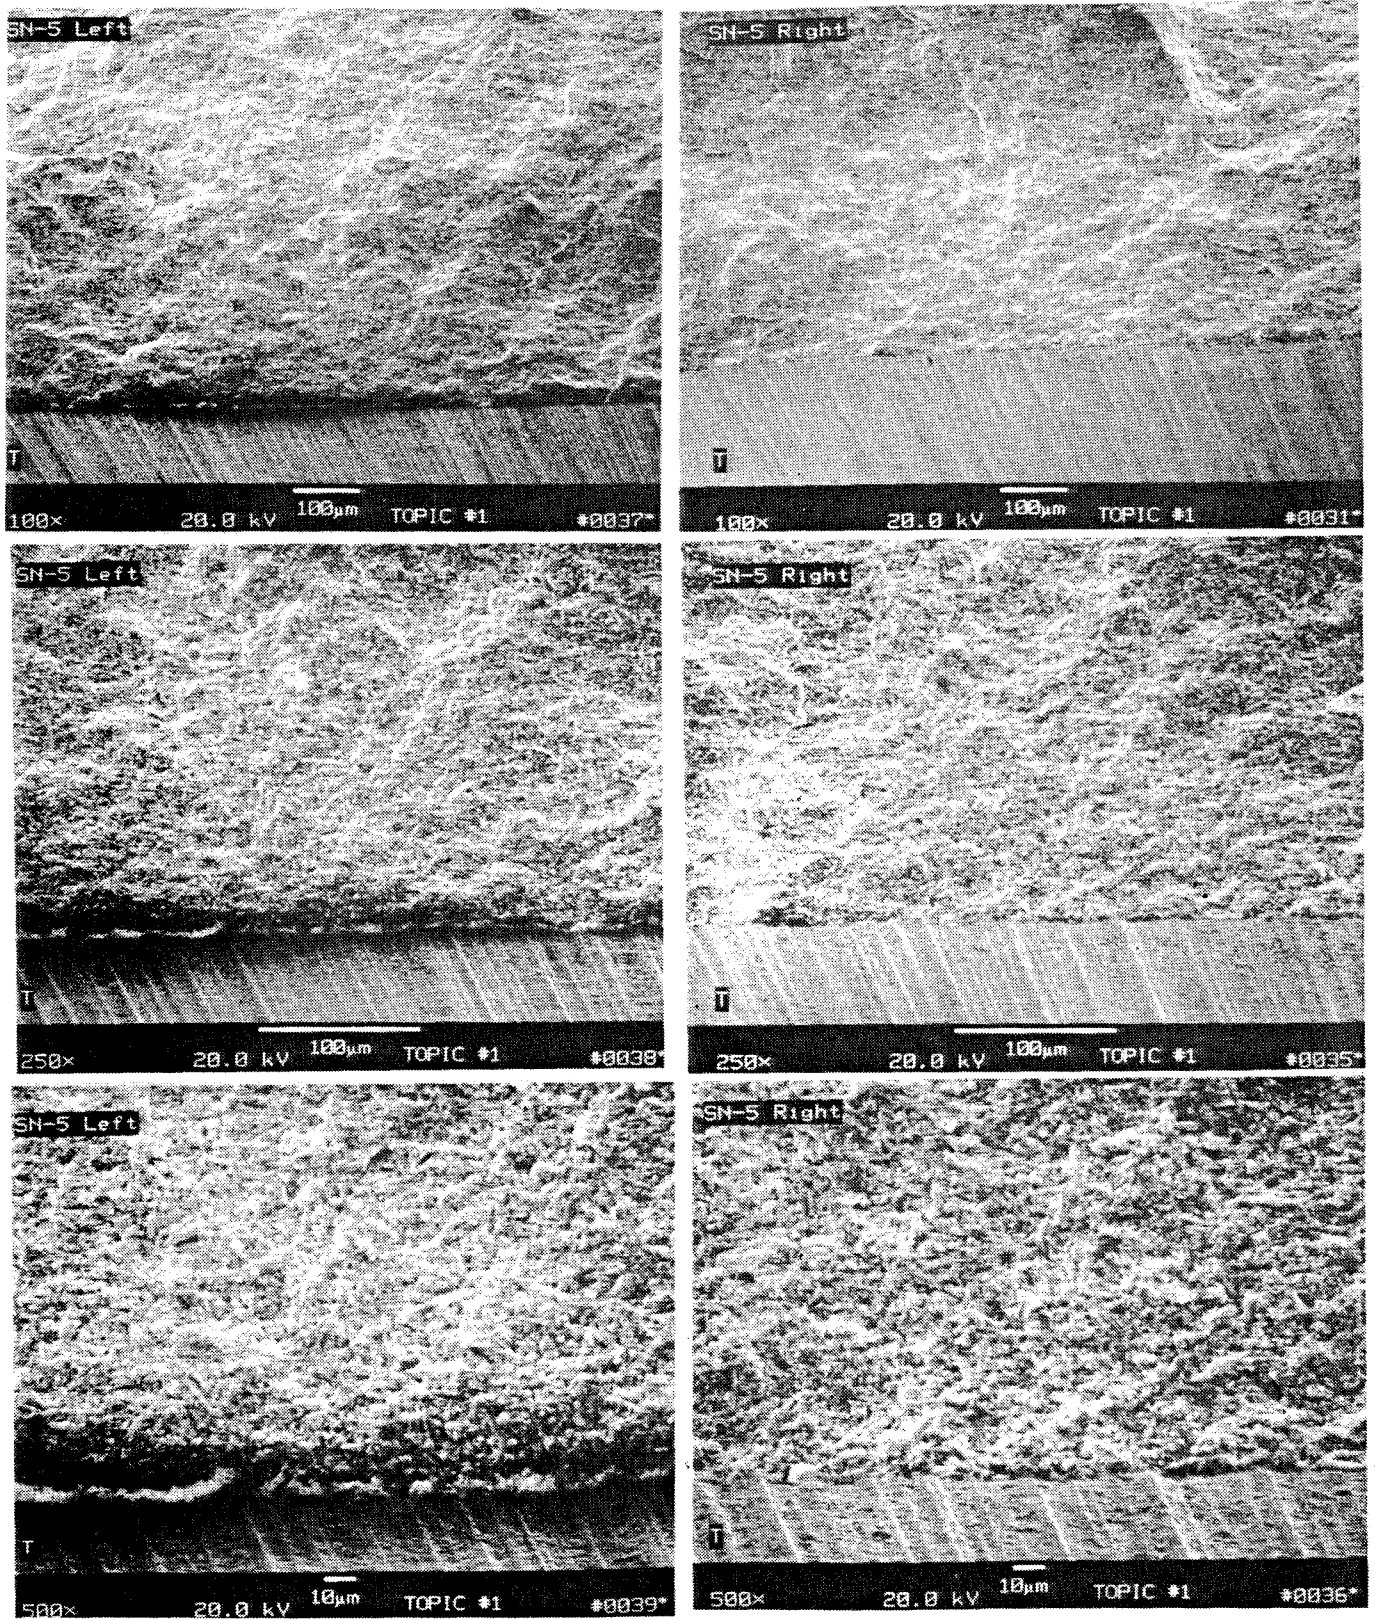
PARTICIPANTS' RESULTS - LOCATION IN SILICON NITRIDE - The consensus was that the origin was located at the surface, however, there were three participants who felt the origin was located elsewhere. One felt it was located "at the edge", one thought it was "near-to-the-surface", while the third was not sure if it was surface or near surface.

Figure 1.4. The three pairs of photographs for Set #2 (SN-5) which were provided to the participants. "T" denotes the tensile surface.

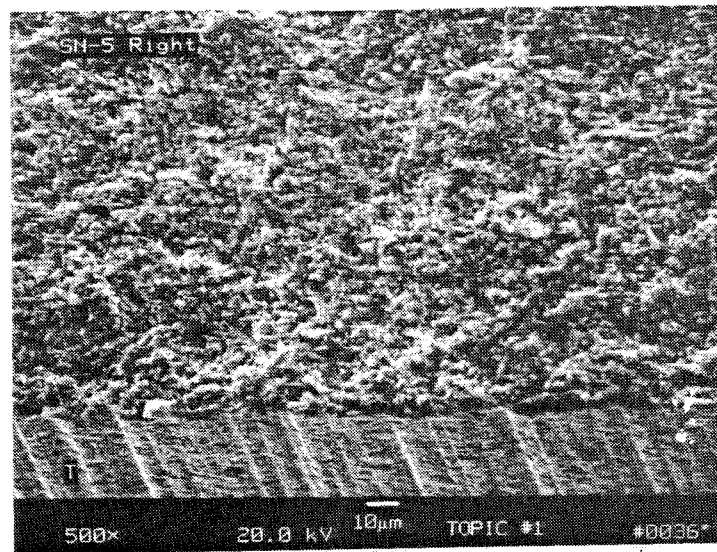
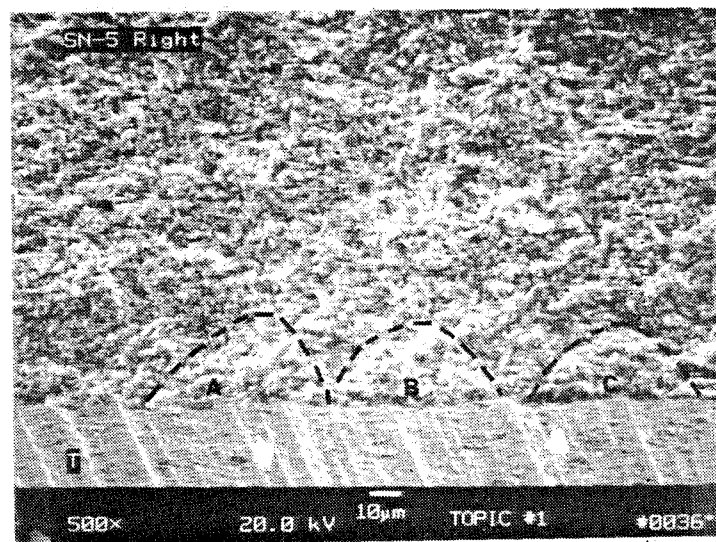
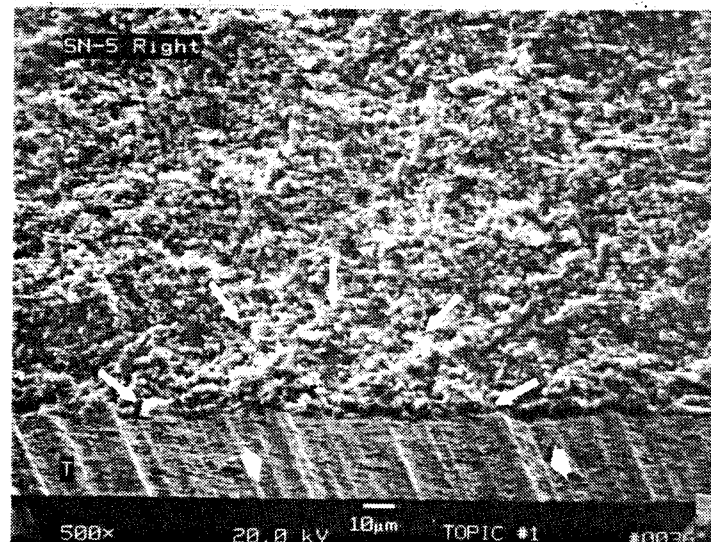
Figure 1.5. High magnification photographs of one half of the fracture surface from Set #2 (SN-5). A) Unmarked. B) The organizers outlined three possible semicircular origins. Arrows indicate possible striations on tensile surface. C) The organizers outlined a possible semielliptical origin. "T" denotes the tensile surface.

In set #2 (Silicon Nitride) the organizers feel the machining damage also had a semicircular or semielliptical shape. An alternate interpretation is that several small semiellipses merged into one larger one as illustrated by the dashed line in Figure 1.5C. Such linking has been reported previously³⁰. Three subsurface cracks can clearly be seen in Figure 1.5B. All three are approximately the same size but the crack labeled B is centered in the fracture mirror. Participants 4 and 11 stated that these origins looked like "controlled surface flaws".

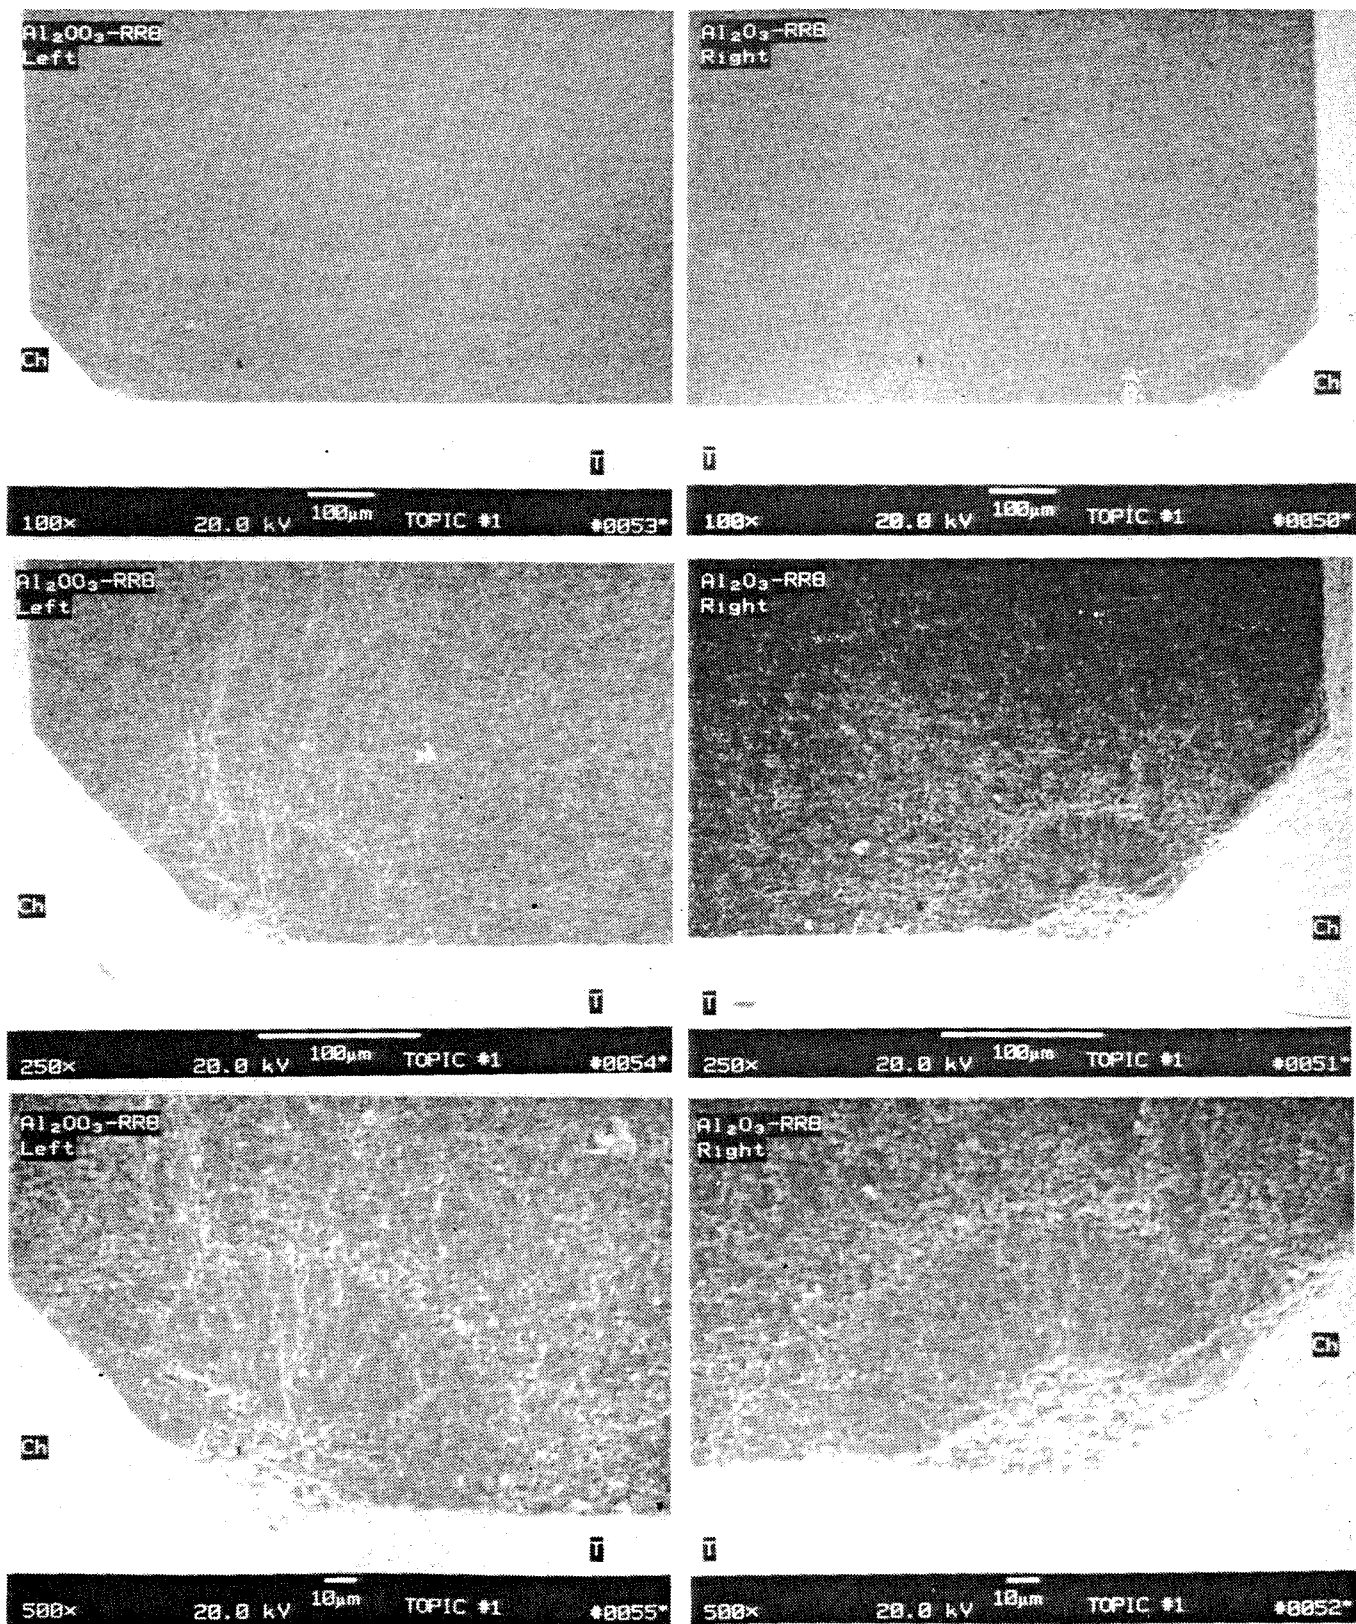
Figure 1.6. The three pairs of photographs for Set #3 ($\text{Al}_2\text{O}_3\text{-RR8}$) which were provided to the participants. "T" denotes the tensile surface and "Ch" the chamfer.

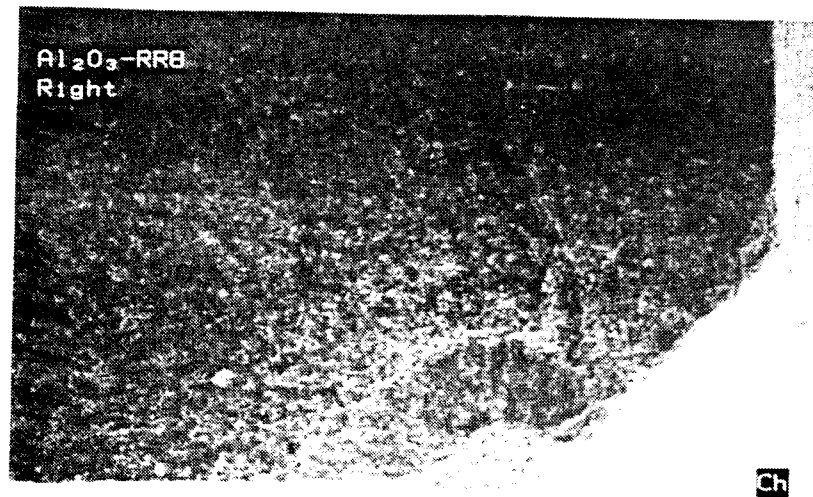
Equation 1b estimates a fracture origin having a size of $c = 182 \mu\text{m}$ ($Y = 1.3$ assuming a semicircular origin at the surface). Two of the four participants (9 & 11) who used fracture mechanics in the previous two sets did so again. Participant 9 used Equation 1a and estimated the toughness to be $2.7 \text{ MPa}\sqrt{\text{m}}$ for $c = 80 \mu\text{m}$ ($Y = 1.3$ from Reference 12). Participant 11 used Equation 1b and was in agreement with the estimated size of the origin. Participant 5 did not indicate the use of fracture mechanics but the radius reported ($c = 120 \mu\text{m}$) is close to the estimated value. Three participants (4, 5 & 11) indicated that these photographs may also show evidence of subcritical crack growth (SCCG).

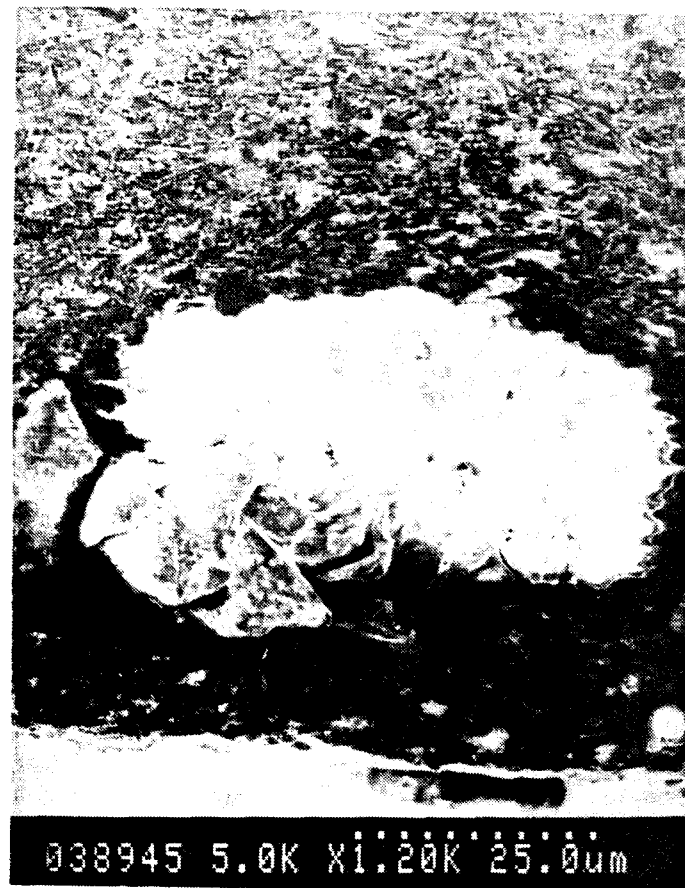
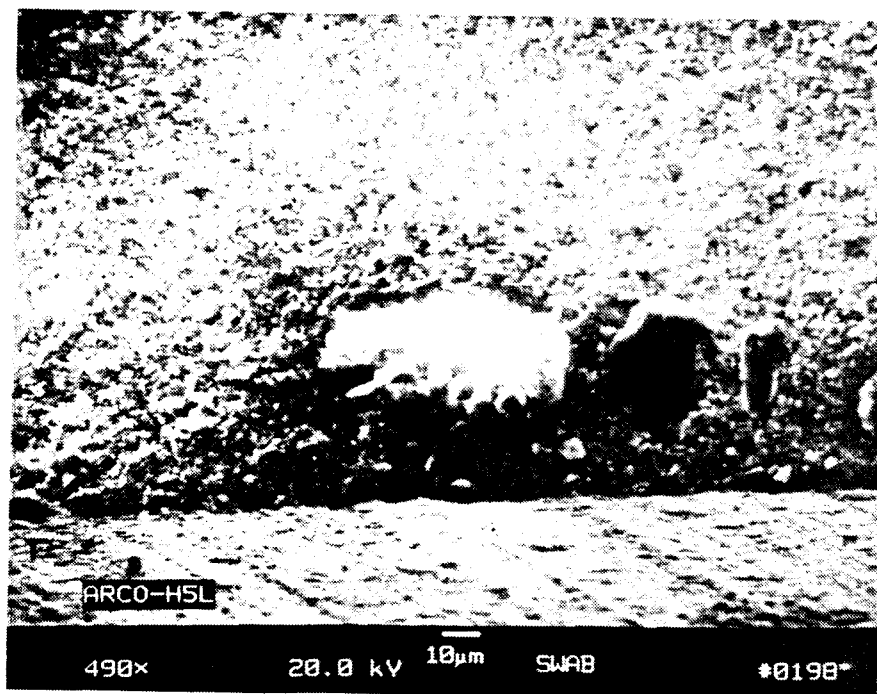
One is the failure to use EDS to analyze the chemical composition of the origin. Participants 2 and 11 labeled the origin as an inclusion (IV). Neither participant used EDS. In both cases the organizers' and participants' photographs of the origin are identical. Figure 2.1.2 shows the participants' and the organizers' photographs of the origin in participant 2's specimen. EDS of these origins by the organizers revealed a high Al content with no Si. This indicates that the origin may be large alumina grains. Another reason for the inclusion label could be the appearance of the large Al_2O_3 grains when viewed

Figure 2.1.2. Photographs of large grain fracture origin in specimen 1 from participant 2 specimen set. A) Participants' photograph. B) Organizers' photograph. "T" denotes the tensile surface in B).

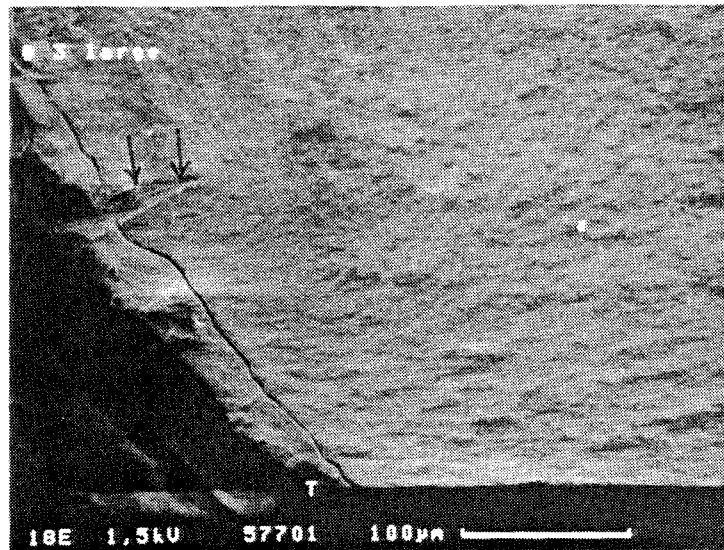
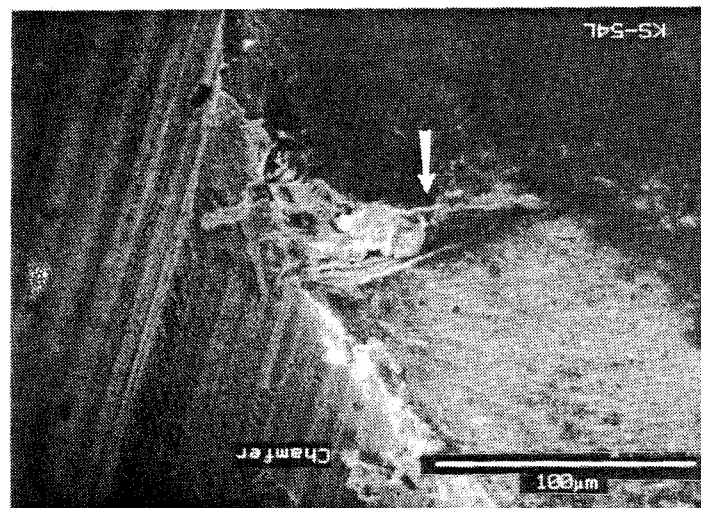
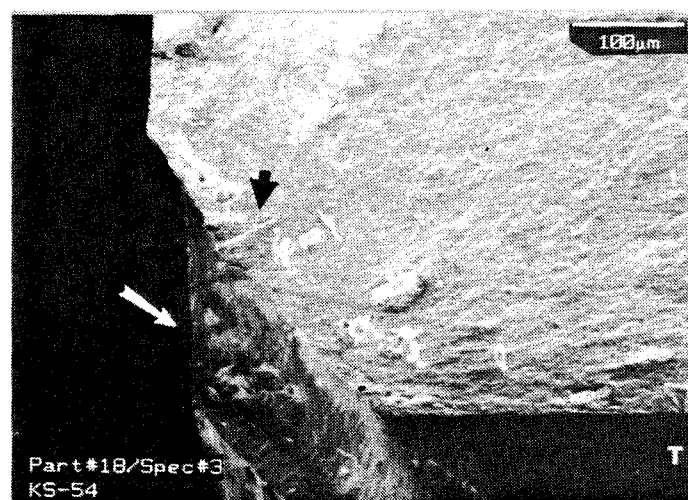
Participant 11 noted the presence of a crack associated with the pore thus the combined label (P/CK), but only one of the primary fracture surfaces was examined with the SEM. Participant 18 also saw a crack in the area of the origin, Figure 2.3.4A, giving rise to the machining damage label, but this crack cannot be seen in any of the organizers' photographs, Figure 2.3.4B, taken prior to the participants' characterization. The organizers reexamined this specimen

Figure 2.3.4. SEM photographs of specimen 3 from the set sent to participant 18. A) Participant 18's photograph. The participant used hand drawn arrows to show the pore. B) SEM photograph taken by the organizers' prior to sending the specimen to the participant. C) Organizers' SEM photograph of the fracture origin after it was characterized by the participant and returned to the organizers. Black arrow indicates the pore and white arrow shows where the piece was removed. "T" denotes the tensile surface.

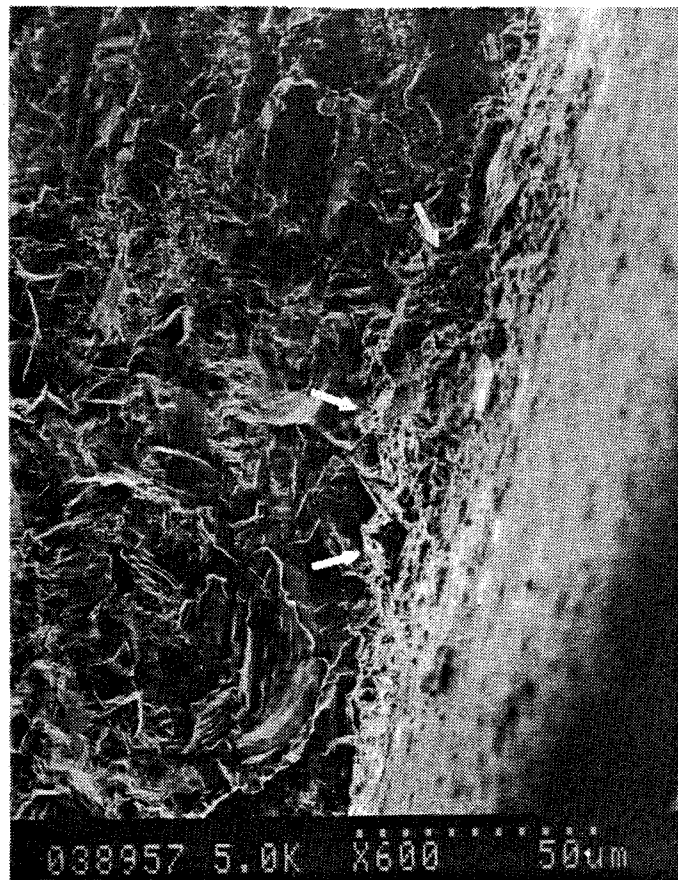
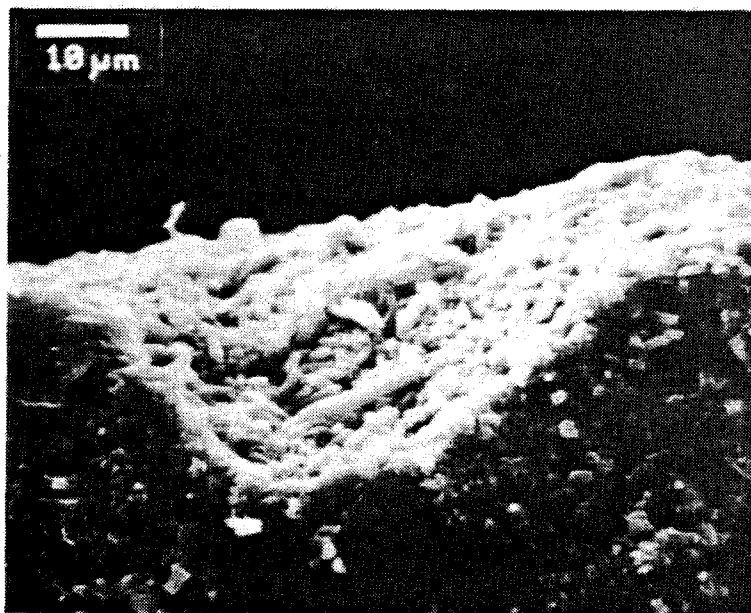
Figure 2.4.2. A) Participant 2's SEM photograph of the pit in specimen 4. Arrows added by the organizers. B) SEM photograph of a surface void from Military Handbook 790, Figure 33, page 40. Note the similarity.

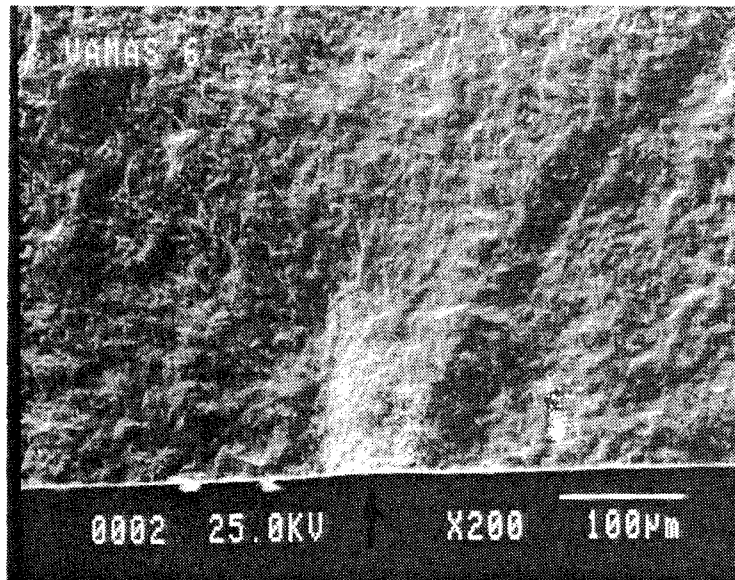
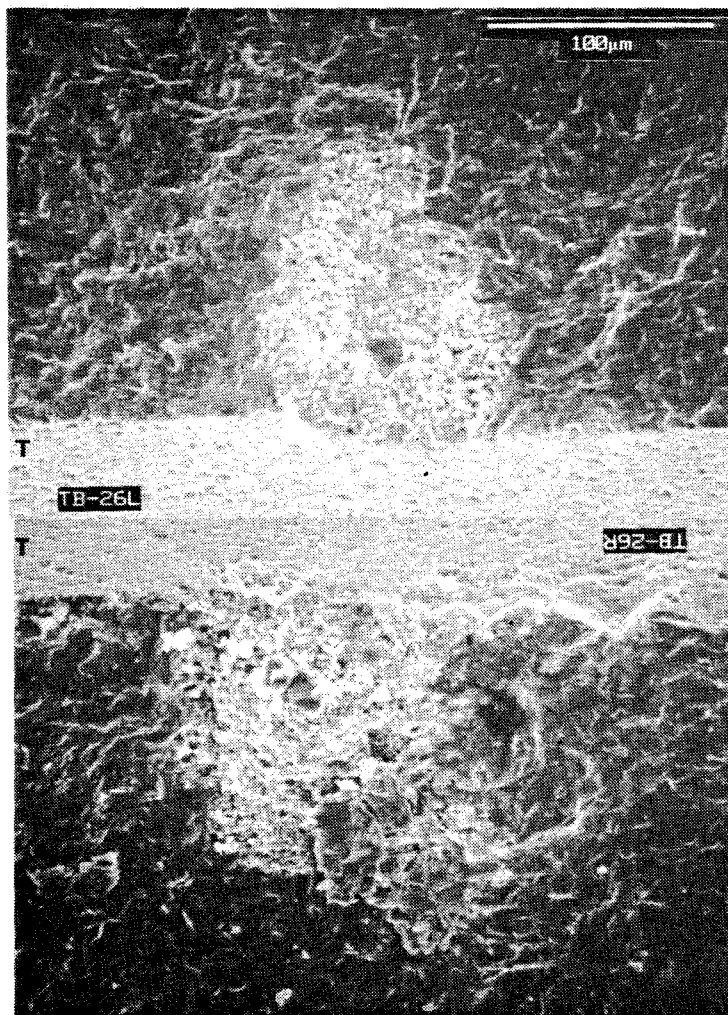
Figure 2.6.2. SEM photographs of specimen 6. A) Participant 15's photograph. B) Organizers' photographs of the mating halves of the primary fracture surface. The photographs in B) indicate that this origin is a porous region (PR^V) and not an agglomerate (A^V). "T" denotes the tensile surface.

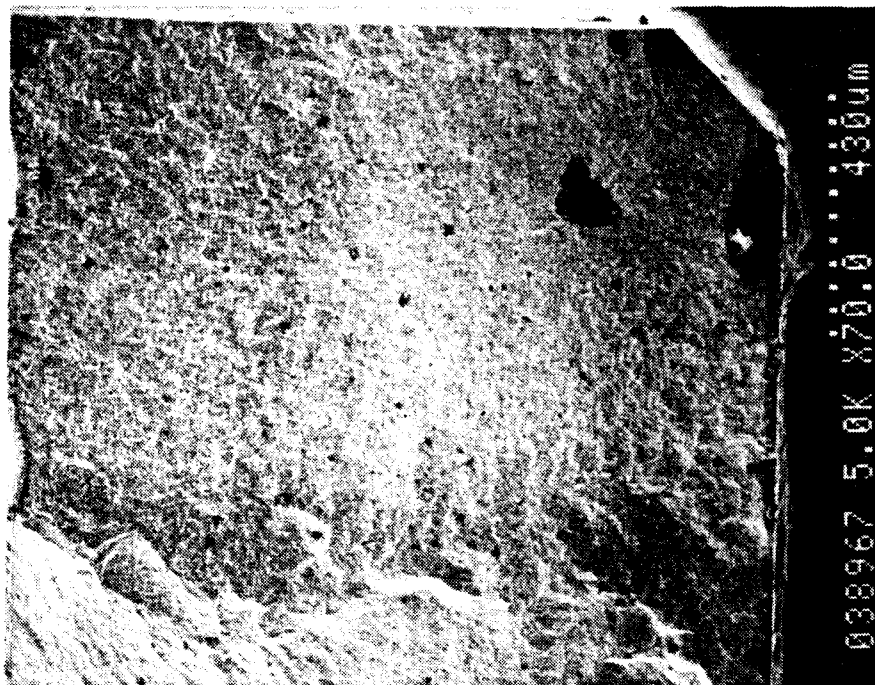
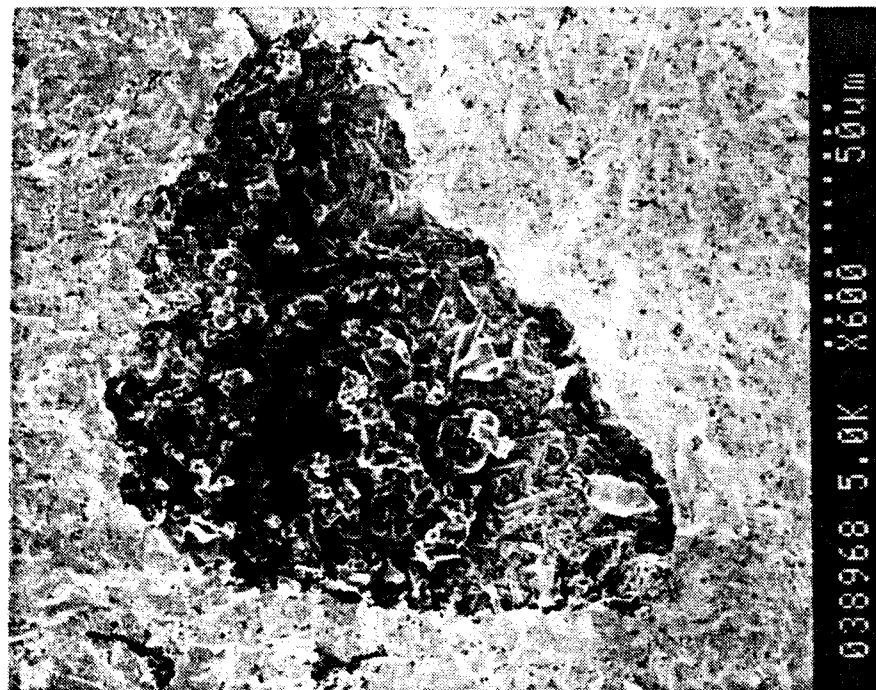
Table 3.1 and a Weibull plot, Figure 3.1, summarize the strength and fractographic information. Fifteen flexure specimens were used to generate these data but the fracture origins in only three of the specimens were characterized. All three specimens failed due to pores (P^V), see Figure 3.2. The participant realized that the examination of only three specimens was not a sufficient characterization of the material but this was part of work in progress and complete characterization of the sample set could not be completed in time for this exercise.

Figure 3.2. Example of the fracture origin, pore (P^V), seen in the β -SiC analyzed by Participant 2. A) 70X. B) 600X.

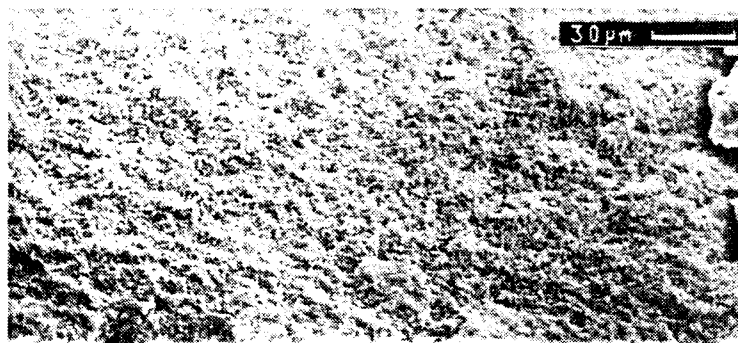
The individual results of the testing are listed in Table 3.2 and a Weibull plot associated with this data are given in Figure 3.3. One hundred specimens were fractured in this analysis and the fracture origins in 26 of these were characterized using the SEM. Figure 3.4 shows some examples of the origins which were encountered. The characterization did not include an origin size measurement nor did it truly identify the origin type. The Weibull plots in Figure 3.3 censor the data based solely on the location. Such an analysis can be misleading. Although the location is an important attribute MIL HDBK-790 states the location "shall not" be used to statistically differentiate the distribution of the origin populations. Since volume-distributed origins, such as pores, can be randomly distributed throughout a material, individual origin locations could be at the edge, surface, near the surface or in the volume. Statistically differentiating based on origin location can imply that there is more than one origin type in the material, when in fact there is only one.

Figure 3.4. Examples of the fracture origins seen in the HIPed Si_3N_4 analyzed by Participant 6. A) Specimen LP-37, Surface at surface? B) Specimen LP-29, Chip located at the edge. C) Specimen LP2-26, Inclusion located in the volume.

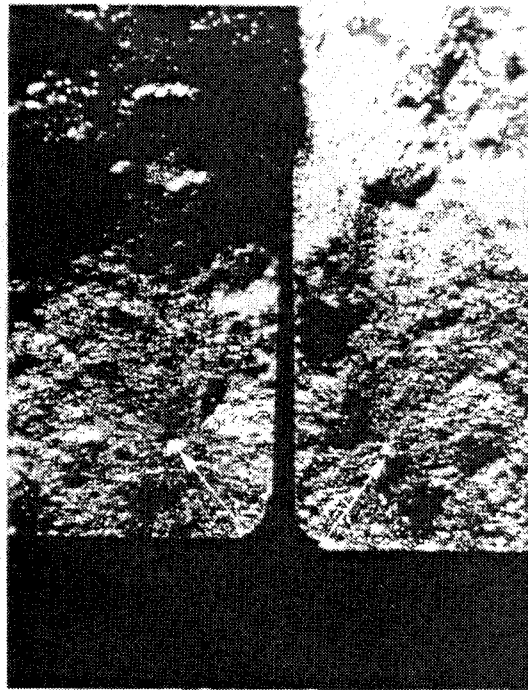
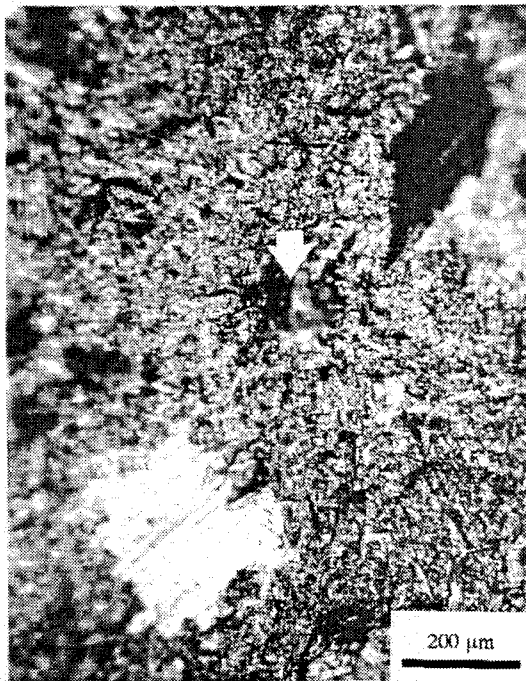
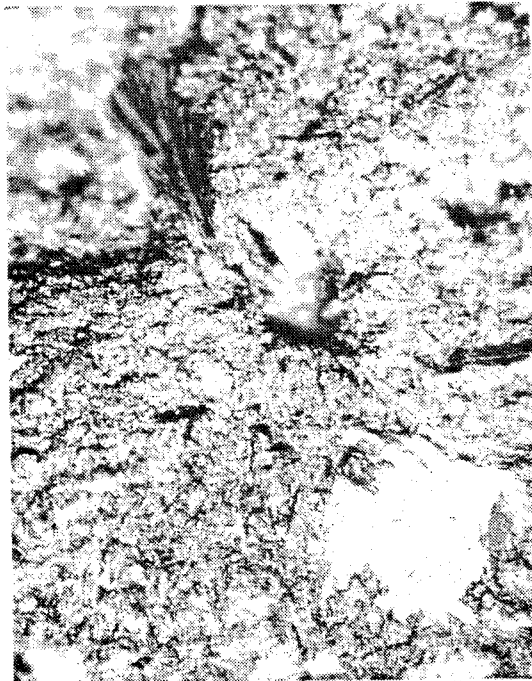
The first specimen was a sintered SiC. No processing details were available. The specimen had a fracture stress of 314 MPa. Optical examination of the fracture surface at 25X using grazing incidence illumination revealed that the origin was located near one of the corners, Figure 3.9A. At an optical magnification of 100X using mixed lighting the origin appears to be an agglomerate or an inclusion, Figure 3.9B and C, because there is a raised sphere on one half and a corresponding depression on the mating half. It was noted that even though there are large grains very close to this agglomerate these can not be the origin because river lines pointing to the sphere can clearly be seen in these grains. The origin size was estimated assuming an internal penny-shaped crack, $Y = 1.13$, a fracture toughness of $3 \text{ MPa}\sqrt{\text{m}}$ and a local stress of 180 MPa (This stress took into account the distance the origin was from the tensile surface.). The estimated size (c) is about $218 \mu\text{m}$ which is about twice the reported diameter of the origin.

Figure 3.9. Origins in a sintered-SiC from participant 11. A) Optical photograph taken at 25X using grazing incident illumination. B) and C) Optical photographs of the mating halves of the fracture surface showing the origin. Taken at 100X under mixed lighting. Note large grains with river lines.

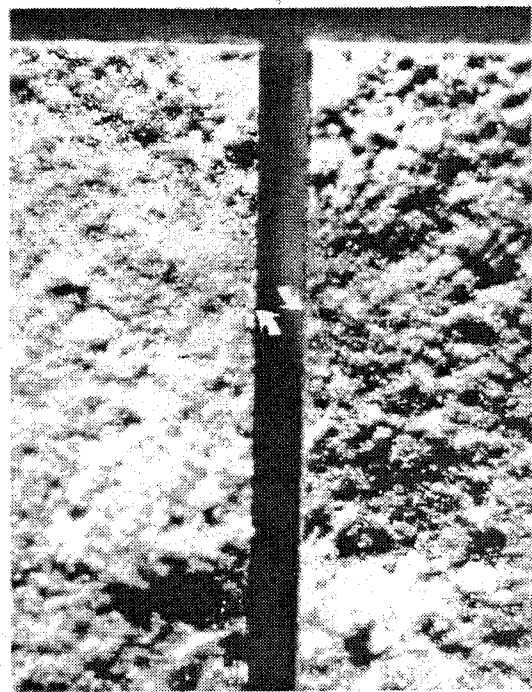
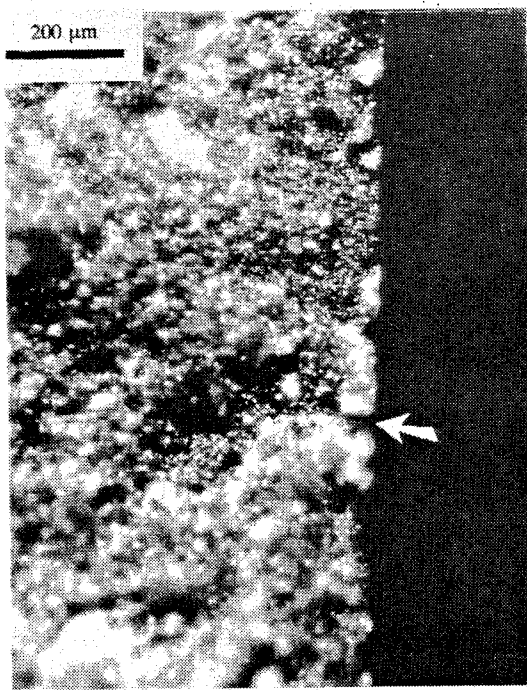
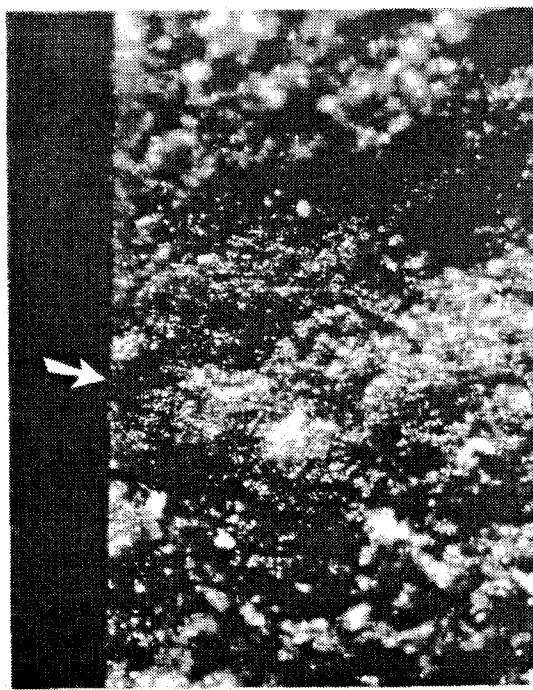
961 and was produced by Morgan Matroc, UK. The alumina grains are typically 3-4 μm with the manganese and titanate phases appearing as sub-micron grains at the alumina grain boundaries. This specimen was machined from die-pressed, fired bars and tested in three-point flexure with a very fast crosshead speed of 5 mm/min. The fracture strength was 366 MPa and the toughness was about 4 $\text{MPa}\sqrt{\text{m}}$. The origin is clearly at or close to the surface, Figure 3.10, thus Y was assumed to be 1.4 and the origin size estimated to be about 61 μm . The participant states that there is a "crack-like defect" visible having approximately the right size. The participant further states "It is known that this material is prepared from spray-dried powder, and it is likely that the crack-like defects are elongated pores left by remnants of particles insufficiently crushed in pressing."

Figure 3.10: Origins in an alumina from participant 11. A) Optical photograph of the mating halves of the primary fracture surface, taken at 25X using grazing incident illumination. B) and C) Optical photographs of the mating halves of the fracture surface showing the origin. Taken at 100X under mixed lighting.

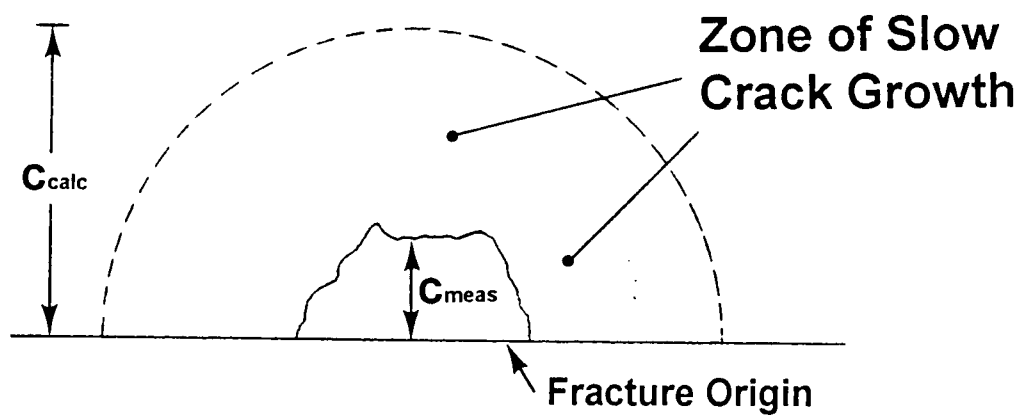
Figure A2.1 Slow crack growth may cause an origin to grow. Fracture occurs when the crack has extended to the critical size which should be the same as the size predicted from fracture mechanics (c_{calc}). If the SCG zone is not detected, then it will appear that c_{calc} is larger than c_{meas} .

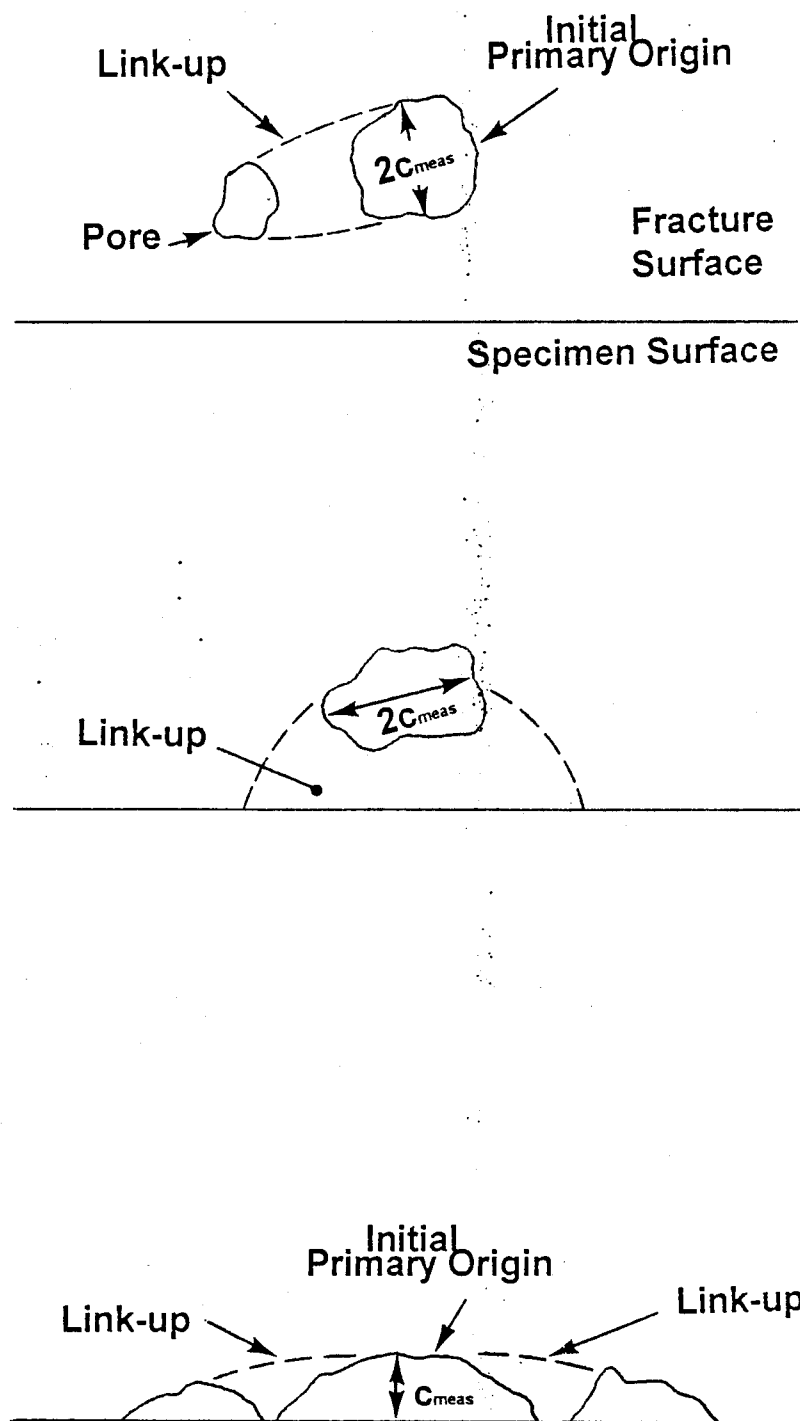
Figure A2.2 A origin can link-up with other discontinuities or with a free surface. The calculated size (c_{calc}) will be larger than the size of the original or initially-obvious origin feature (c_{meas}).

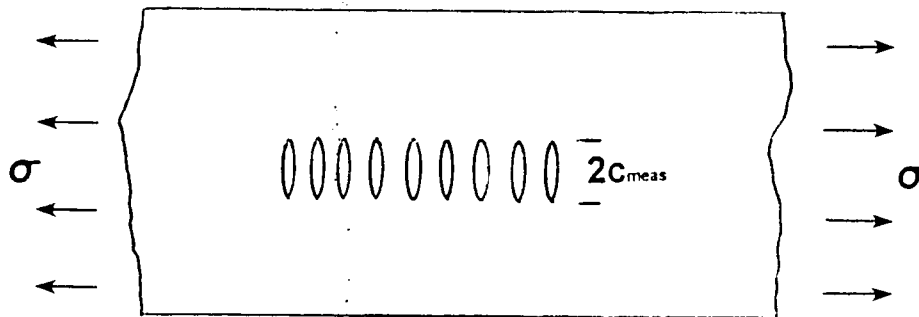
Figure A2.3 Nested, overlapping cracks can lead to a reduction in the stress intensity (γ) at any single crack. In this case c_{calc} will underestimate the crack size measured on the fracture surface (c_{meas}).

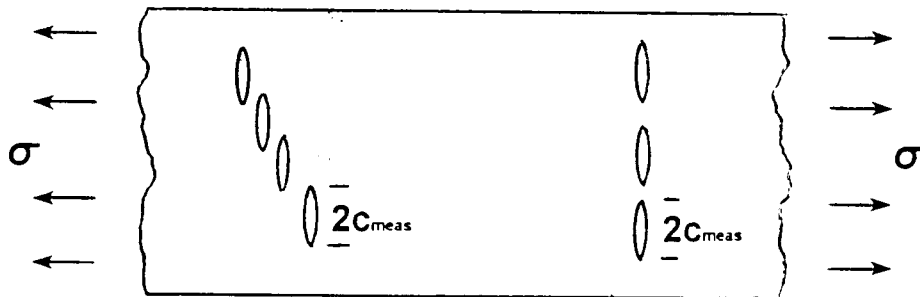
Figure A2.4 Staggered or aligned cracks can cause the stress intensity (γ) to be magnified at the fracture origin. c_{calc} will overestimate the measured crack size (c_{meas}).
